# ASSURED MARINE SURVEY LTD.

## MARINE SURVEY REPORT

### Pre-Purchase

2017 Boston Whaler 345 Conquest - public sample

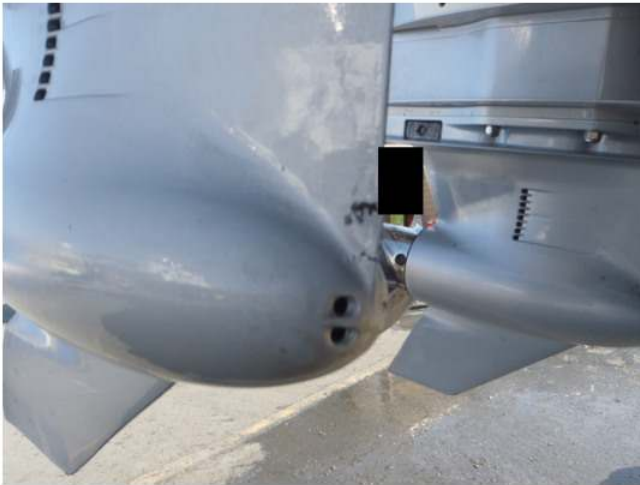
| Component | Installed arrangement / specification | Condition and material observations |
|---|---|---|
| <b>Propellers, shafts, struts / drives</b> | Three 1.75:1 outboard gearcases; Mercury Enertia ECO 16-inch diameter × 17-inch pitch propellers. | Stainless-steel propeller blades were in very good condition. Local damage was noted on the starboard aluminium gearcase housing (Photo 7; Recommendation 9). |

Accessible hull surfaces were in very good condition. Starboard gearcase housing damage needs specialist assessment. Concealed structure and measured displacement were outside scope.

**Photo 7 — Starboard gearcase housing damage; Recommendation 9.**

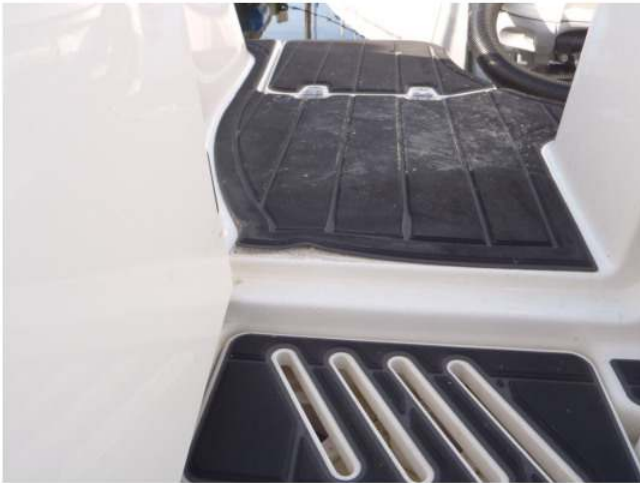
| Component | Installed arrangement / specification | Condition and material observations |
|---|---|---|
| <b>Cockpit sole / hatches / lazarette</b> | aft fishing cockpit with service centres, storage and self-bailing sole. | Composite Ultra-deck cockpit covering was in good condition overall. A local area was lifting at the starboard cockpit entry door (Photo 8; Recommendation 10). |

**Photo 8 — Lifted Ultra-deck at starboard cockpit entry; Recommendation 10.**

Accessible deck/superstructure finishes presented well overall. Roof/cabin percussion and random moisture checks were recorded; deck-specific coverage was not separately documented. Rebond the lifted cockpit covering. Window resealing is reported history.

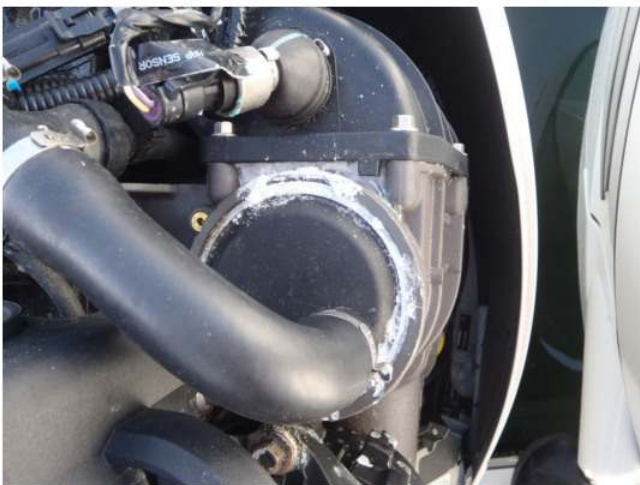
| Component | Installed arrangement / specification | Condition and material observations |
|---|---|---|
| <b>Cooling systems / hoses / clamps</b> | Water-cooled charge-air cooler assemblies; F [3]. | With cowls removed, white salt-like deposits were observed at the upper charge-air cooler/end-cap areas on the centre and port engines. The centre photograph was annotated as seepage. Source, seal condition and residue composition require Mercury-technician assessment (Photos 9–11; Recommendation 2). |

**Photo 9 — Centre charge-air cooler deposits; Recommendation 2.**

| Rec. | Pri. | Material finding | Required response |
|---|---|---|---|
| 2 | B | Port/centre cooler deposits | Mercury assessment and repair verification. |

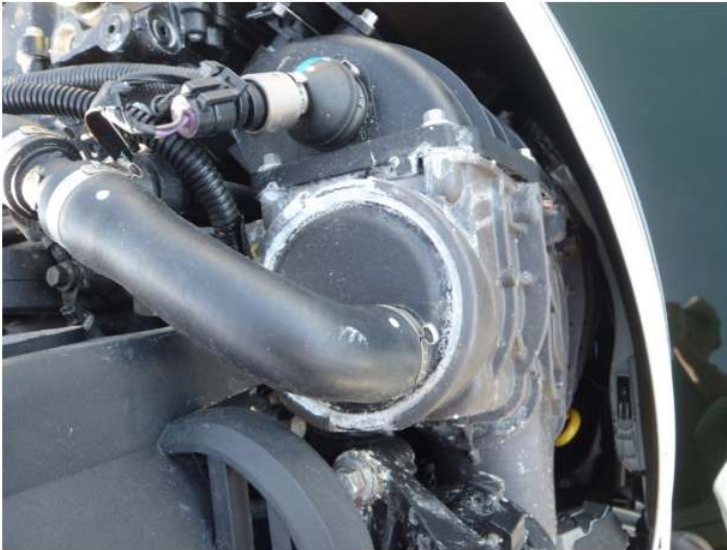
**Photo 10 — Port charge-air cooler deposits; Recommendation 2.**

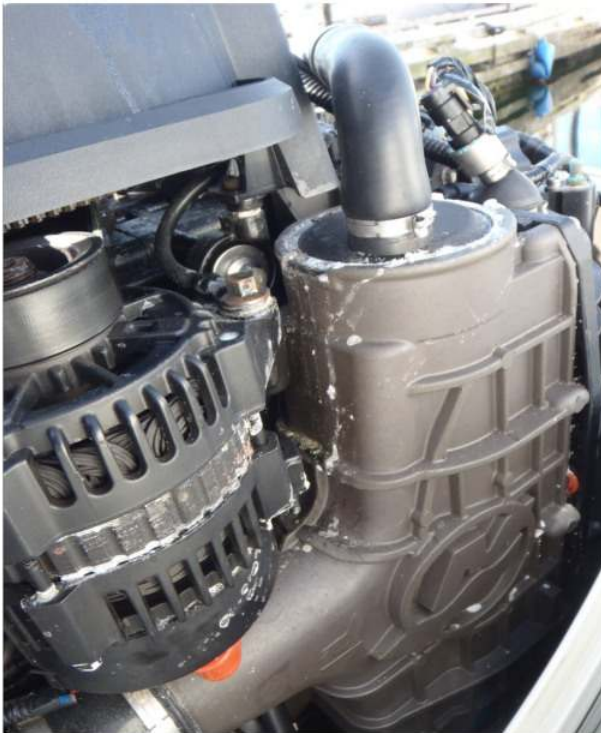
**Photo 11 — Centre cooler area annotated as seepage in the notes; source to verify. Recommendation 2.**
